NASA CR-72996  
BAC Report No. 8489-945001

# FINAL REPORT

## ADVANCED THRUST CHAMBER DESIGNS

Contract NAS 3-7968

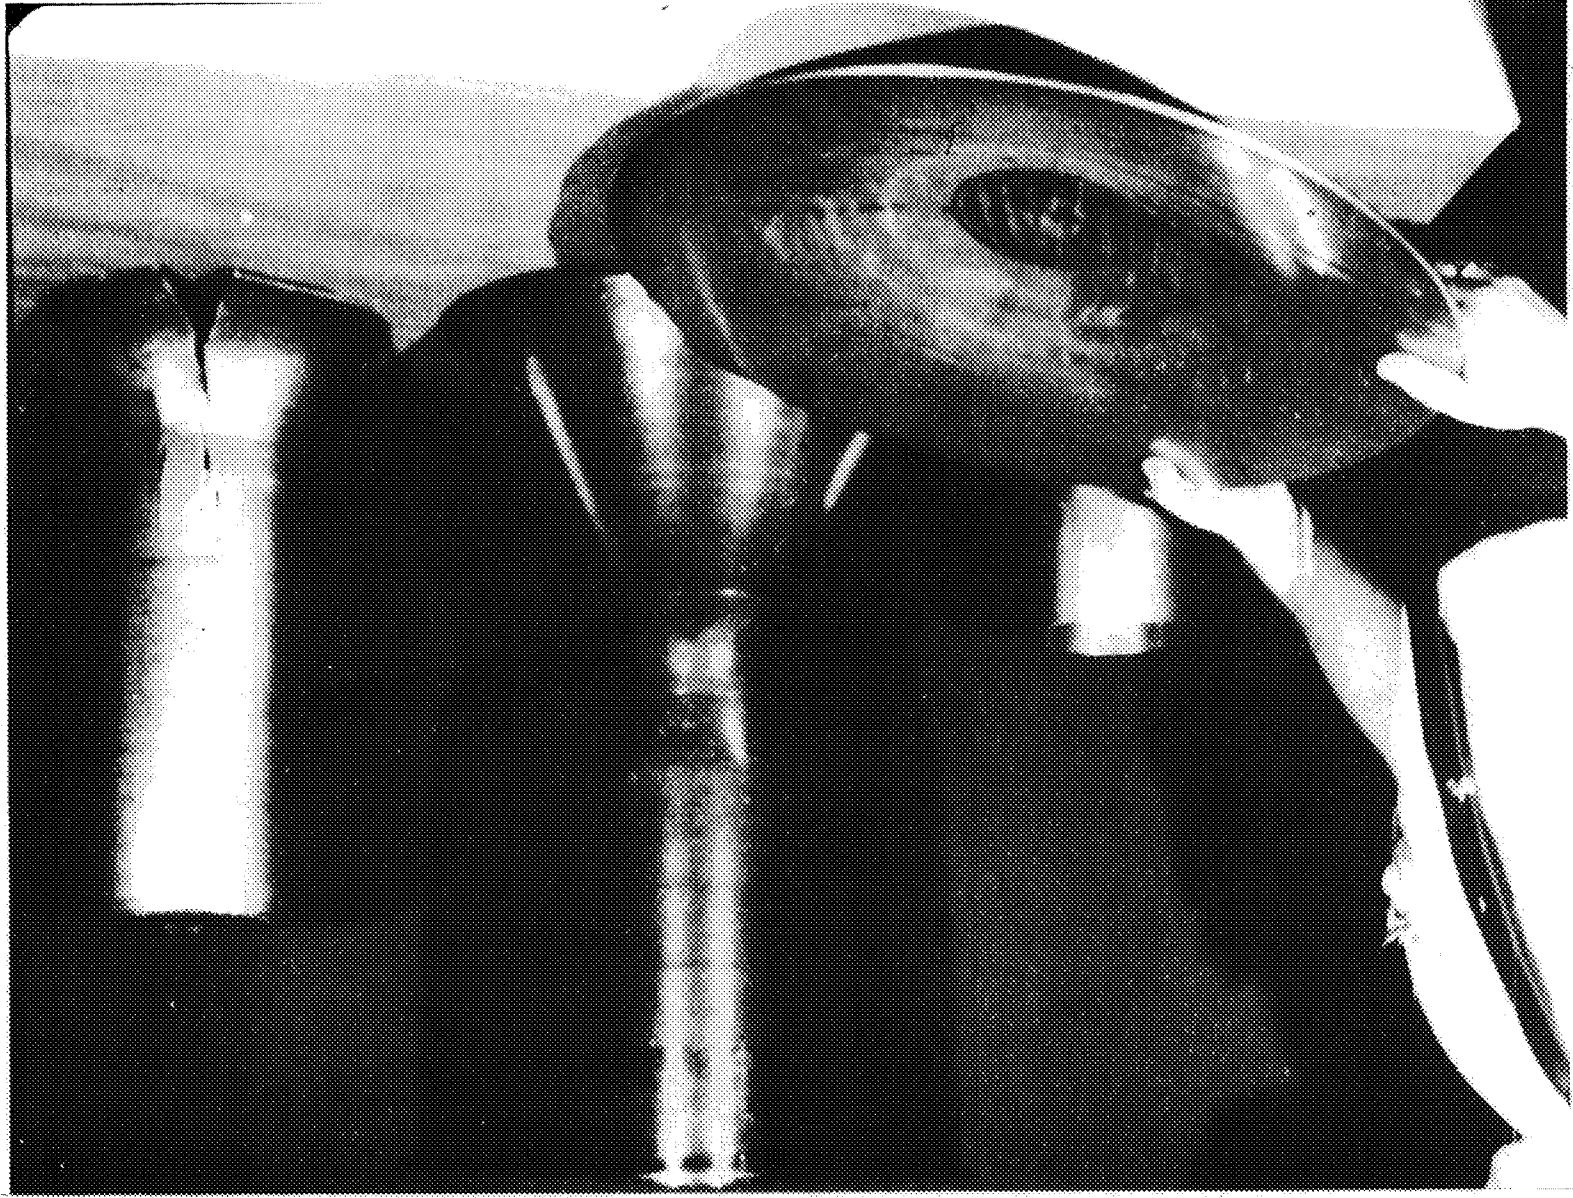
Figure 5. Spin Formed Liner and Defective Preforms

Figures 5, 6 and 7 illustrate successful and unsuccessful attempts at spin forming. Defects in the aft sections shown are the results of spin forming blanks with known areas of delamination. The fracture in the forward section shown in Figure 5 is the result of excessive reduction during a single spin forming stage.

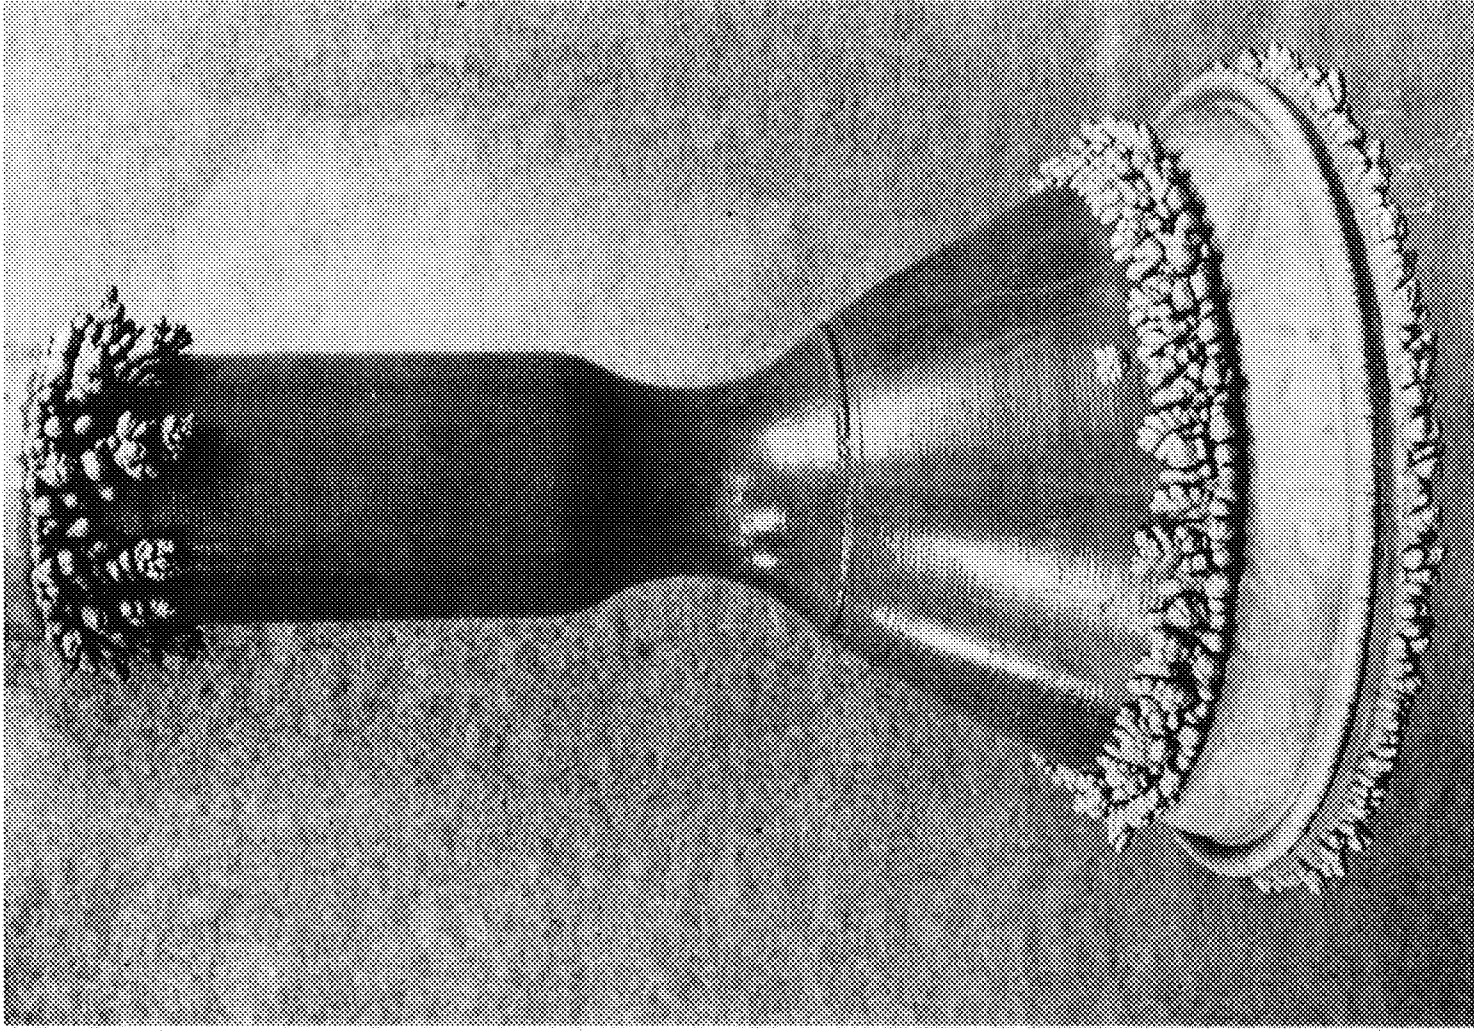
Figure 15. Nodular Growth During Electroforming of Flanges

Nodular growth, caused by high current densities at the edges of the flanges, was not completely eliminated. The extent of nodular growth is illustrated in Figures 14 and 15. The rate of nodular growth was somewhat inhibited with procedures established for preferential deposition (use of plastic shields).

The electroforming process had to be interrupted on numerous occasions to allow removal of surface defects and nodules and to restore suitable surface and flange profiles for continued plating. This correction was accomplished locally by hand grinding with belt and disk grinders or by turning in a lathe when major correction was required. This restoration procedure led to the need for a restarting and replating process.

The surface treatment previously described was used for surface preparation prior to plating. However, the nitric acid treatment was deleted for restarting. The electrodeposit of nickel was reactivated with an anodic sulfuric acid treatment. This anodic deoxidation provided for good adhesion and allowed plating buildup to continue without evidence of lamination.

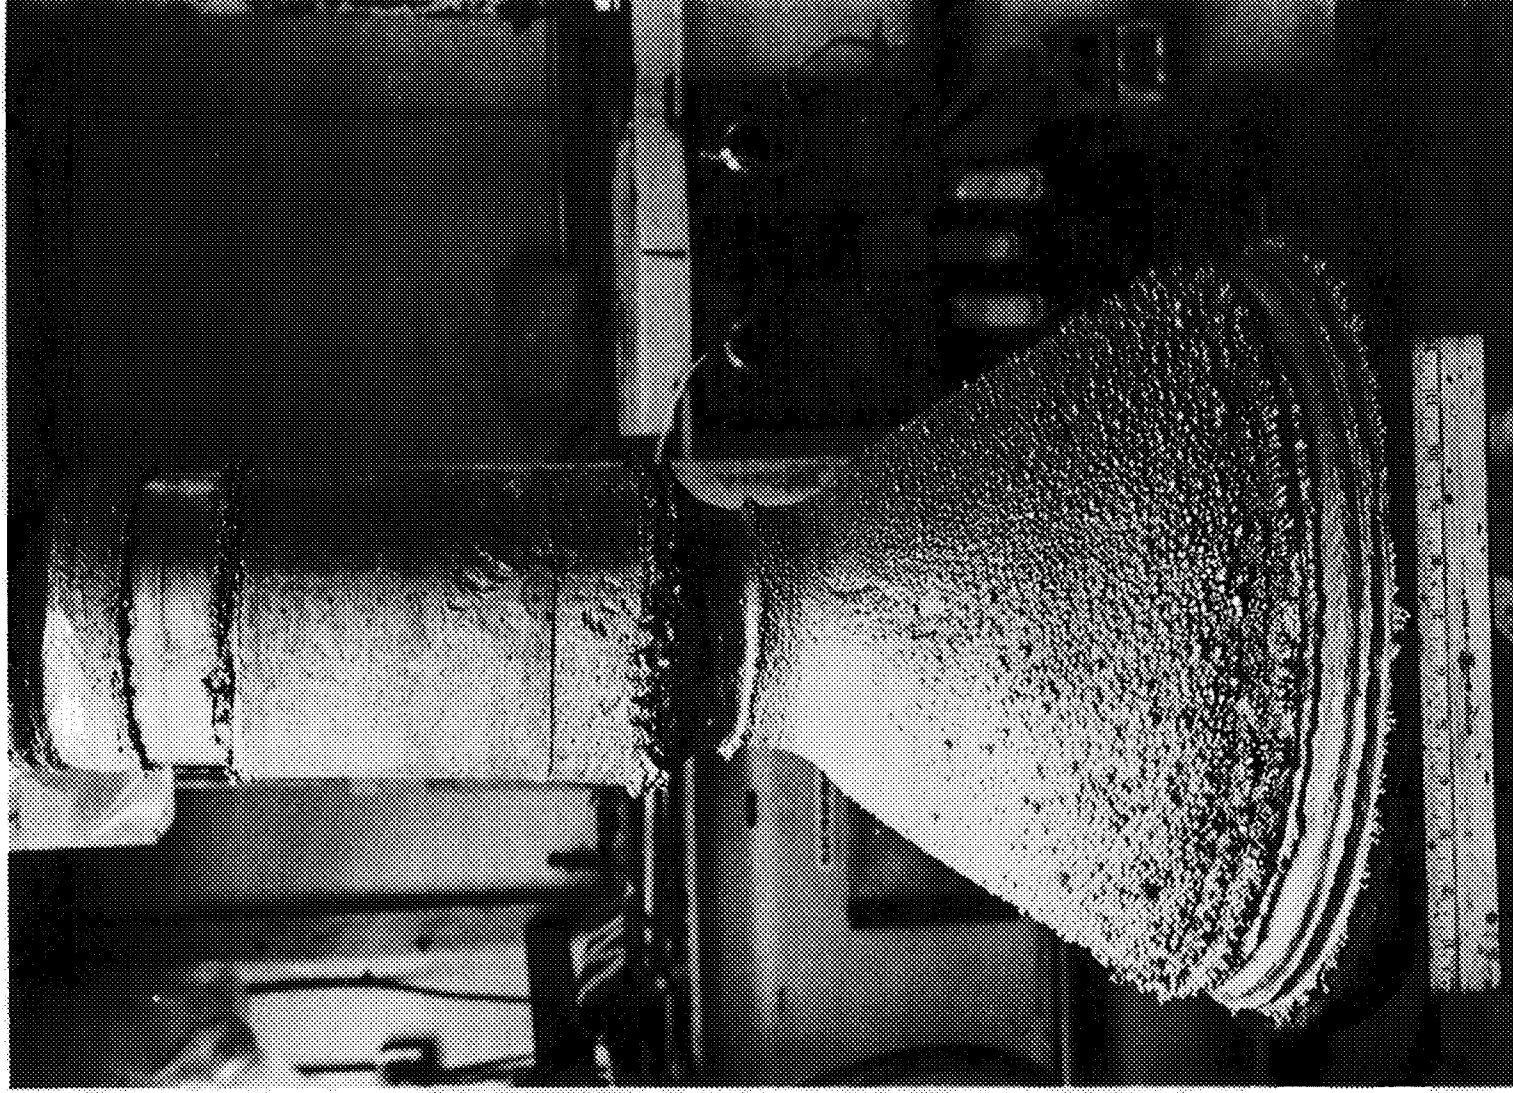
Figure 21. Thrust Chamber at Completion of Electroforming

The surface roughness problem, illustrated in Figure 21, generated the need for a surface conditioning procedure. Surface conditioning consisted of grinding the chamber surface with disk and belt grinders to restore a smooth surface of sufficiently accurate configuration suitable for additional nickel buildup. In order to do this the glass inserts had to be removed from the instrumentation holes and the chamber had to be mounted in a fixture on centers so that it could be rotated while grinding. After grinding, new glass inserts were installed in the instrumentation holes.

Figure 21 shows the chamber after complete electroforming. It is evident in the photograph where preferential deposition of the nickel had to be achieved. Surface roughness and the tendency toward nodular buildup also is in evidence. Upon completion of electroforming the chamber was dimensionally checked to assure that sufficient electroform buildup had been obtained over the entire surface of the chamber to allow for final machining to blueprint configuration.

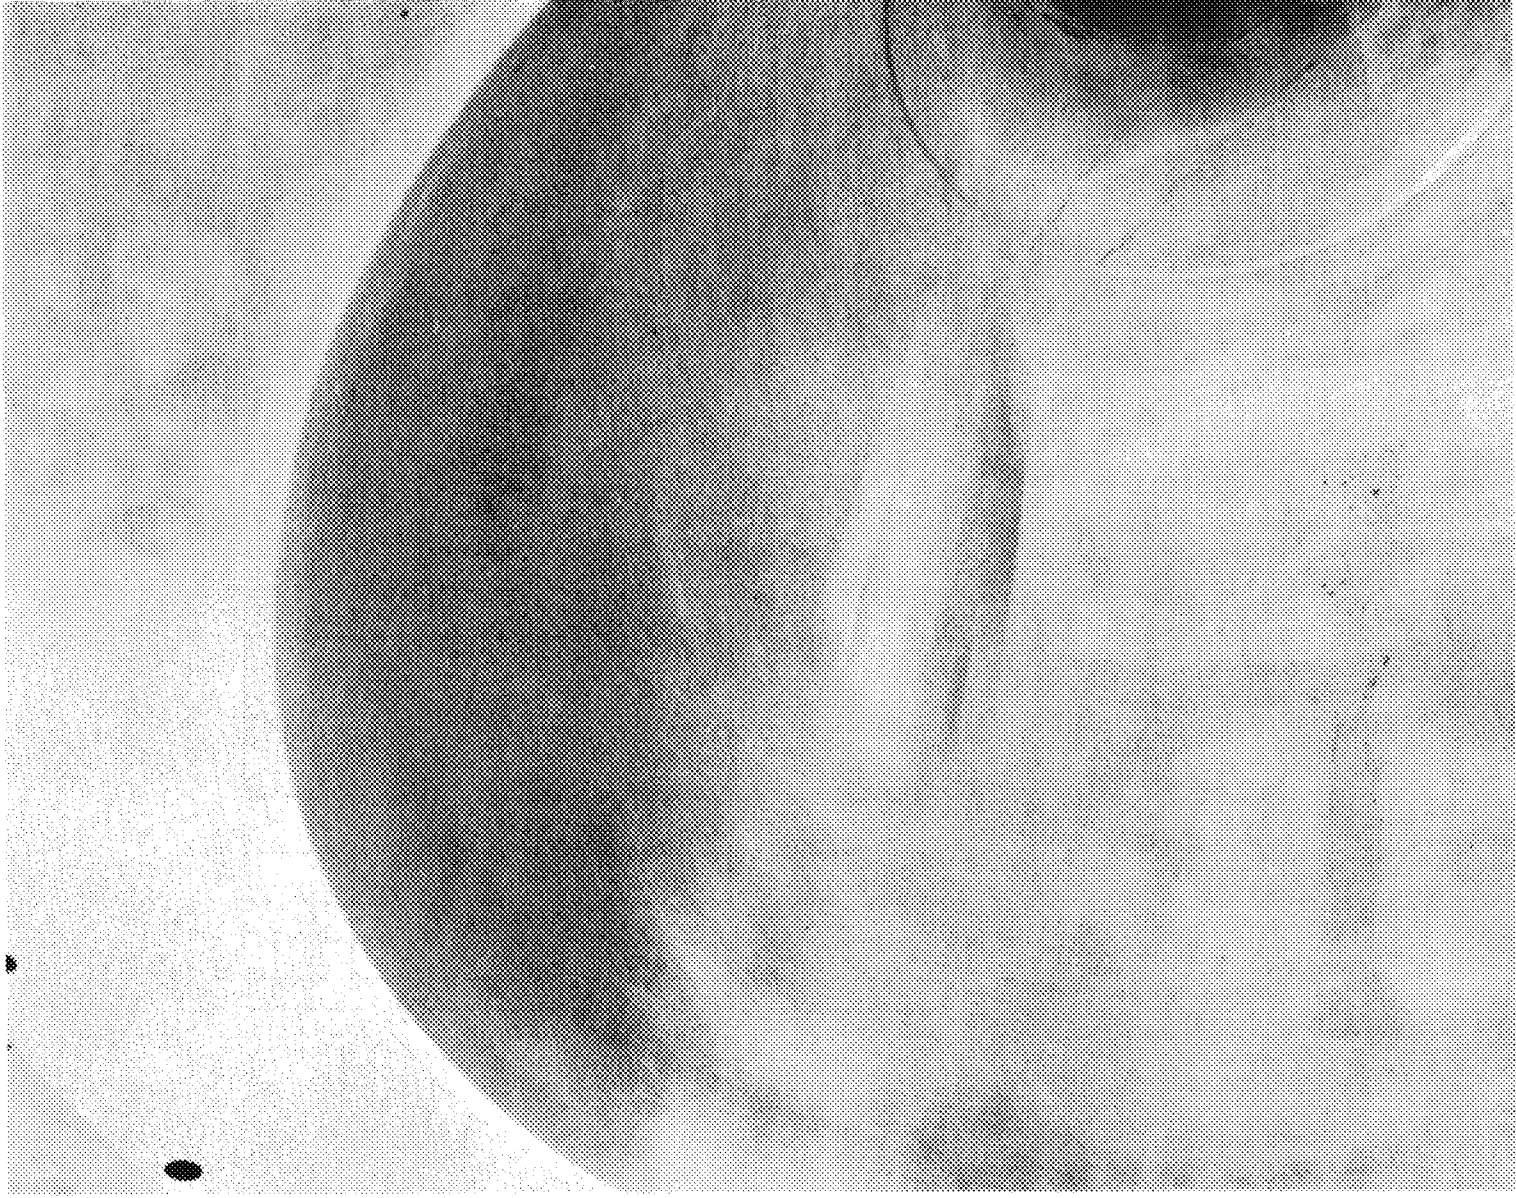
Figure 47. Top View Inner Liner Bulge

A thrust chamber was completed employing the processes developed. During the hydraulic pressure phase of preliminary testing, a bulge developed in the aft section of the TD Nickel inner liner at 550 pounds pressure which subsequently was found to be caused by a separation of the inner liner channel lands and the electrodeposited outer nickel shell.

No conclusive reasons for bond separation evolved from the investigation of material trepanned from the bulged region. There exist possible causes which are discussed below.

A third possible cause is residual stress resulting from the manifold welding. This residual stress could have been superimposed on the pressure test stress, making actual stresses much higher than expected.

A temporary repair of the area and a retest which resulted in a second bulge at 550 pounds pressure led to the conclusion that the interface bond between the TD Nickel liner and the electroformed outer shell was inadequate to withstand internal pressures required of the chamber. It was evident that the process transition from laboratory study to application was not accomplished with complete success. The program was concluded at this point because basic fabrication methods had been successfully demonstrated and further repair attempts were not considered justifiable.
